Manhole Inspection Summary

Manhole # S67M__003MH

Location Address: **6226 O'Donnell St.**

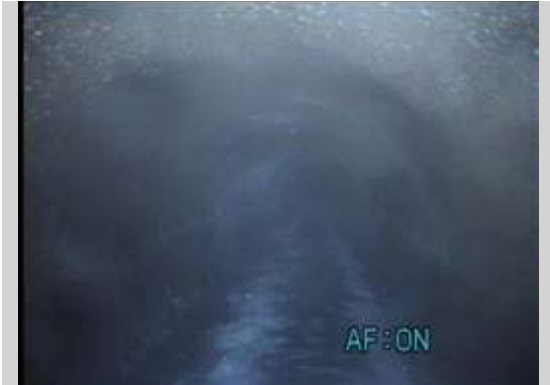
12 O'Clock Outflow

54 in. Circular Gravity Sewer
Pipe Out @ 12 O'Clock

Pipe Height: **56.4** (in.) Rod and Bar (Angled)
Pipe Material: **Concrete** ☐ Pipe Lined
Invert Depth: **15.08** (ft.) Flow Characteristics: **None**
Deposits: ☒ None ☐ Mud ☐ Sludge ☐ **Debris** ☐ Grease
Silt Depth: (in.) Deposits Extent:
Infiltration: **None** Pipe Seal Cond: **Sound**

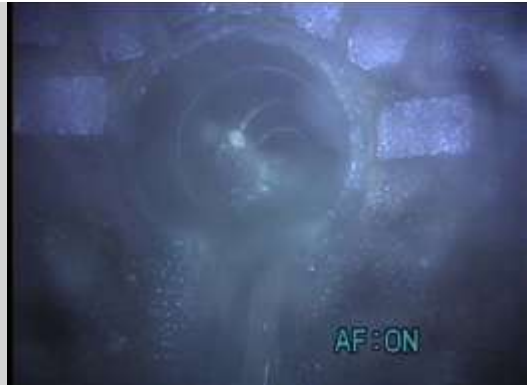
9 O'Clock Inflow

8 in. Circular Gravity Sewer

Pipe In @ 9 O'Clock

Deposits: ☐ None ☐ Mud ☐ Sludge ☒ **Debris** ☐ Grease

Silt Depth: **1** (in.) Deposits Extent: **Light**
